**Dublin San Ramon  
Services District**

# Refurbishing a Continuous Backwash Sand Filter

# Inspection and Refurbishment of a Continuous Backwash Sand Filter

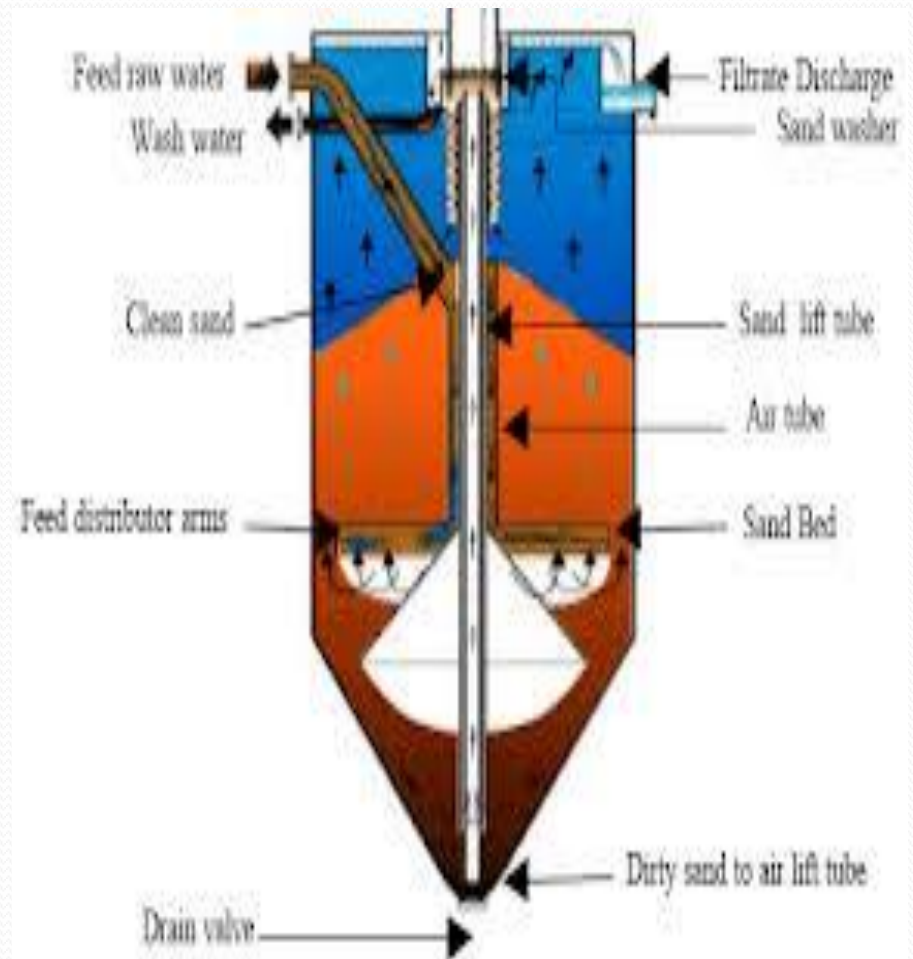
Filter #1 was able to meet the 2 NTU turbidity limit at a loading rate of 3.7 gpm/ft<sup>2</sup> (equal to 8 mgd with all 5 filters running)

Filter #1 was not able to meet 2 NTU at 4.2 gpm/ft<sup>2</sup> (equal to 9 mgd with all 5 filters running)

More extended filter capacity testing will be conducted following rehab of the filter. Analysis of existing media indicates that it continues to meet design specifications.
