# Creek Asset Management Plans

Elizabeth Mercado, Associate Civil Engineer, P.E.

BAYWORK Maintenance & Asset Management Workshop

May 30, 2018

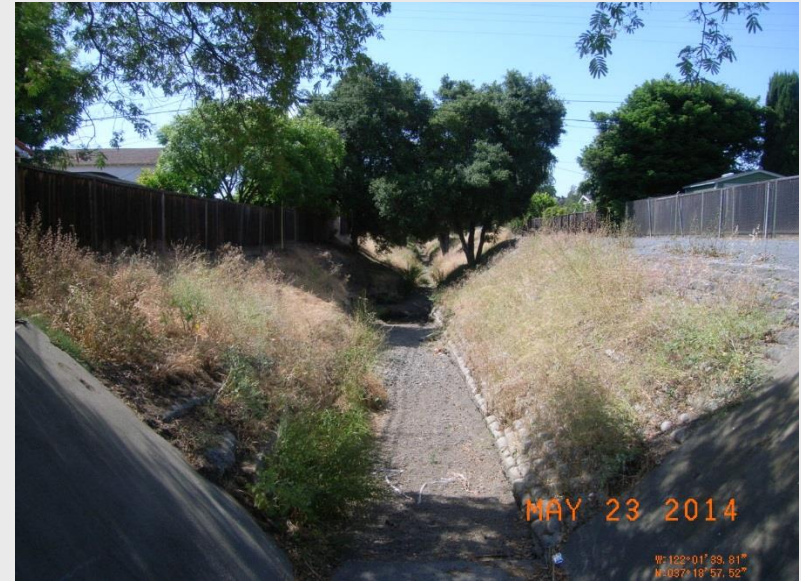
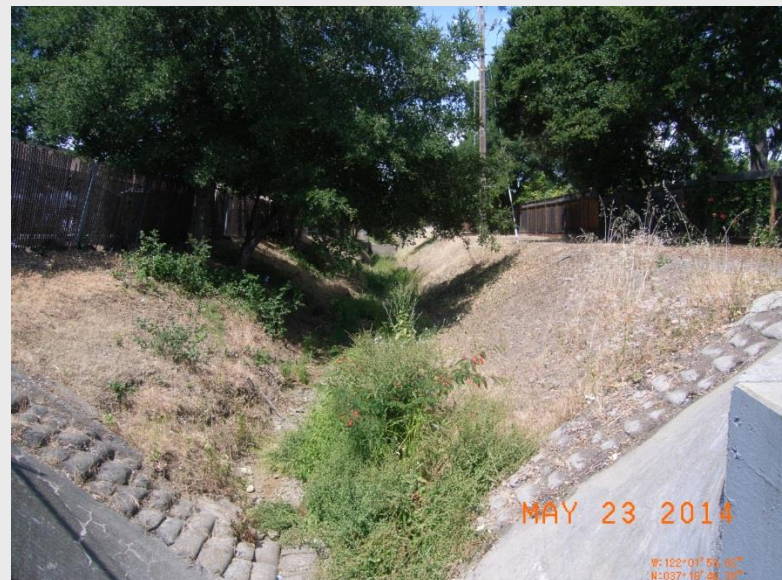
# Regnart Creek

- ▶ Located in the West Valley Watershed
- ▶ Within the City of Cupertino
- ▶ 2.9 miles within District jurisdiction
- ▶ Earth Trapezoidal Channel
- ▶ Erosion vs Sediment

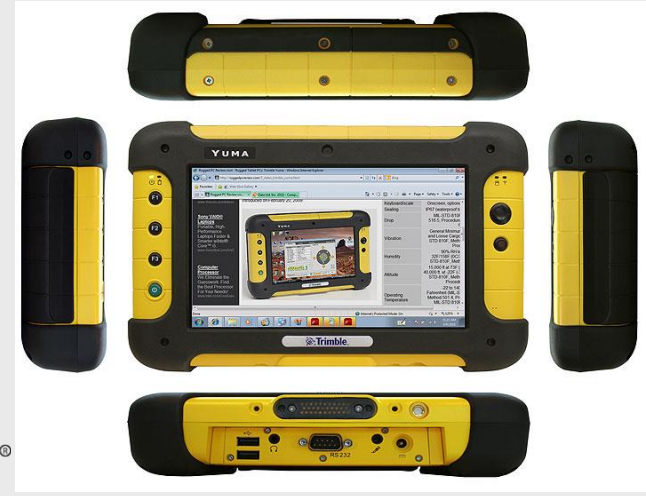
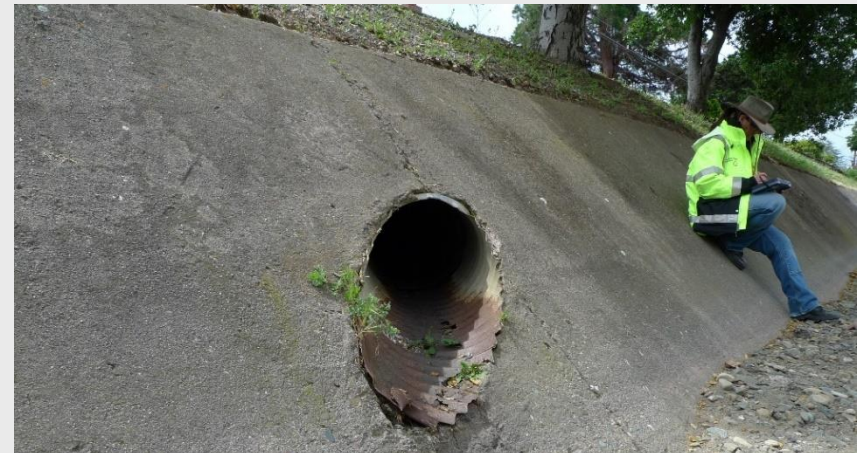
- ▶ Annually inspect channels with A-E (1-5) rating system
- ▶ Mobile Device
  - ▶ Current: Yuma handheld with Arc PAD GIS
  - ▶ Consultant: Tablet and/or Phone with Survey 123 and Collector
- ▶ Data from inspections are synced overnight in Maximo
- ▶ Investigating Maximo Mobile Applications and Software

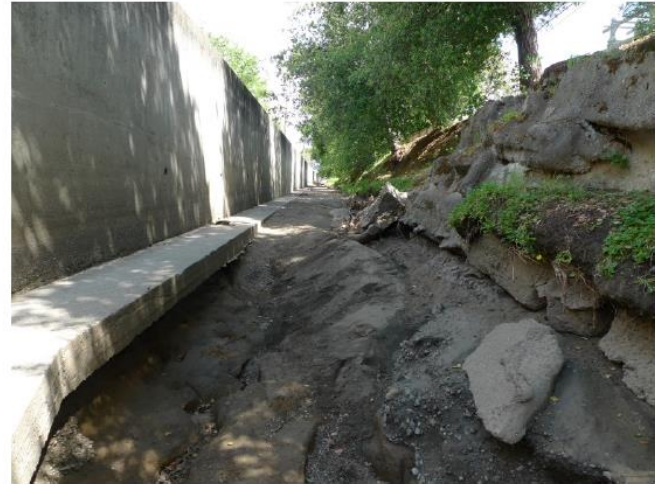
Bed Erosion Will Lead to Accelerated Deterioration of Improvements at Station 31+20

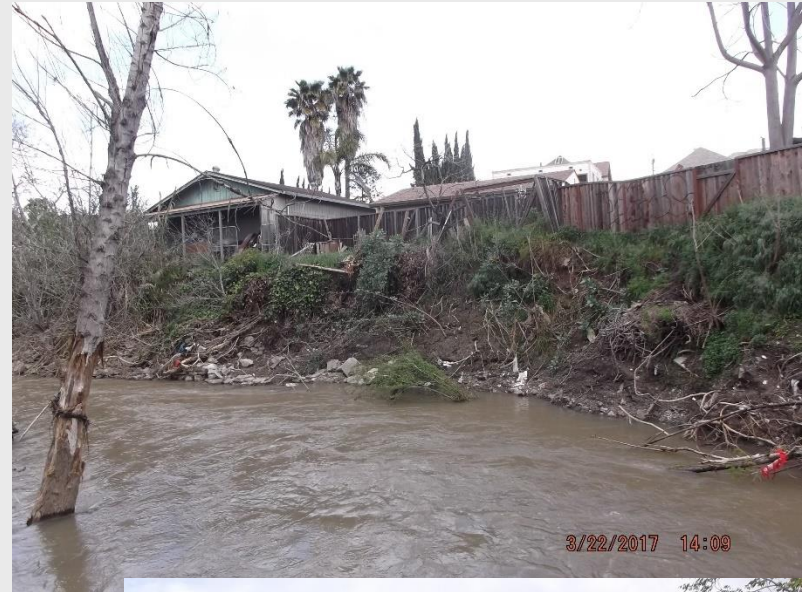
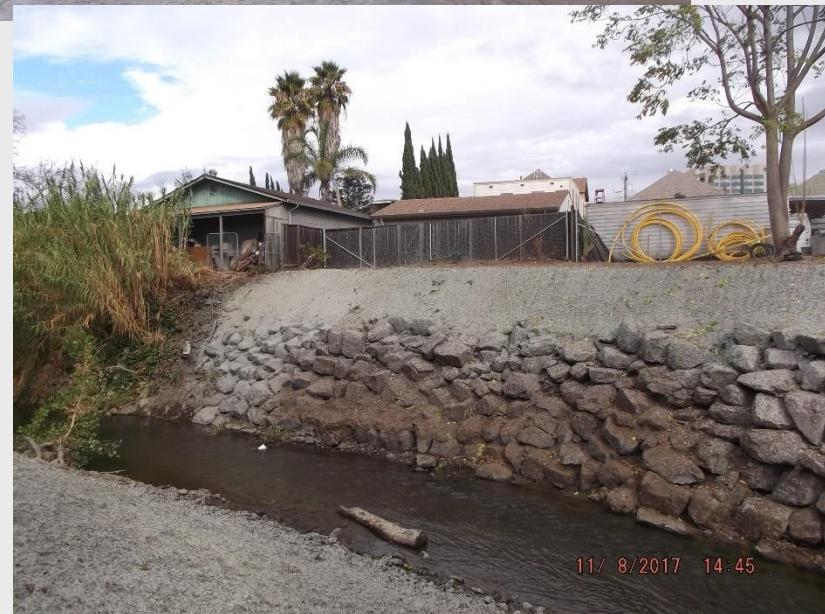
3 Strategies - Baseline, Alternative 1 (O&M and Capital involvement), Alternative 2 (Capital Involvement)

- ▶ Main concepts of Alternative Strategies
  - ▶ Coordination of bank and bed improvements
  - ▶ Improvements of longer creek segments as opposed to spot repair of acute problems
  - ▶ Continued improvement of assets in advance of failure or imminent failure
