# **Chabot Dam Seismic Upgrade Project**

Tom Boardman, Project Manager

November 14, 2018

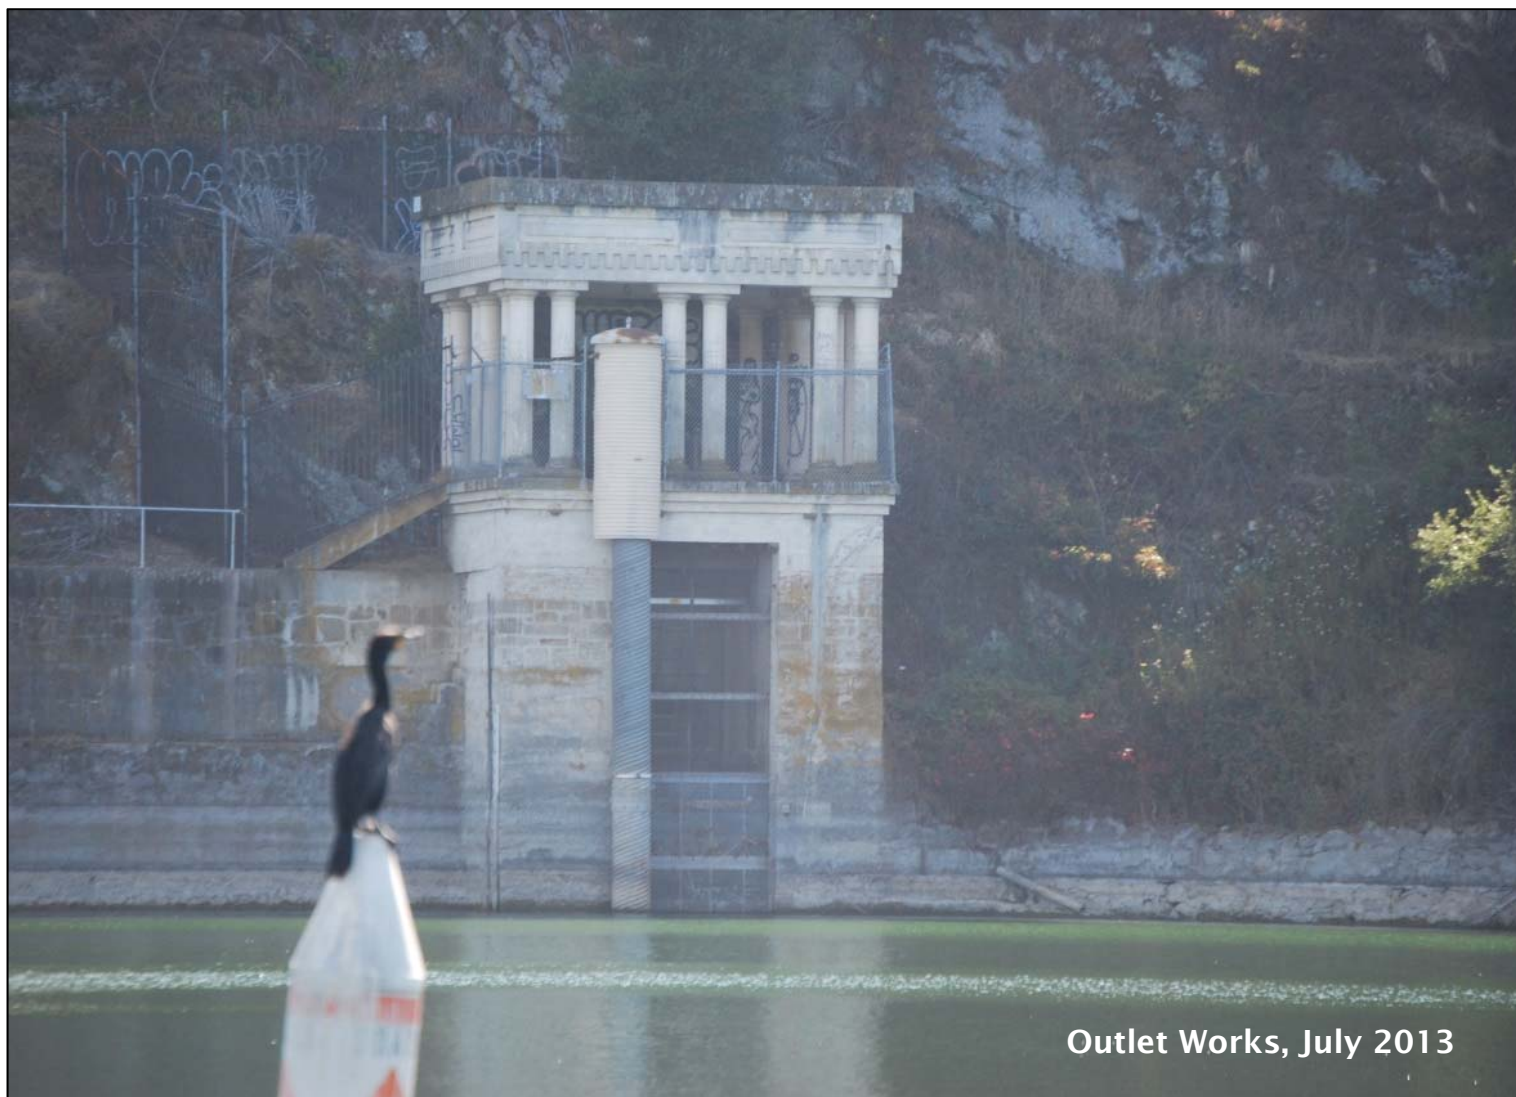
# Outlet Works Retrofit

Outlet Works, July 2013

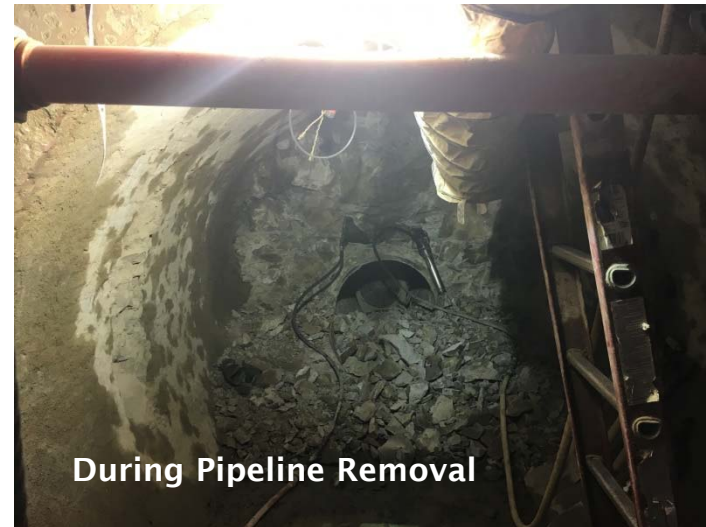
During Pipeline Removal

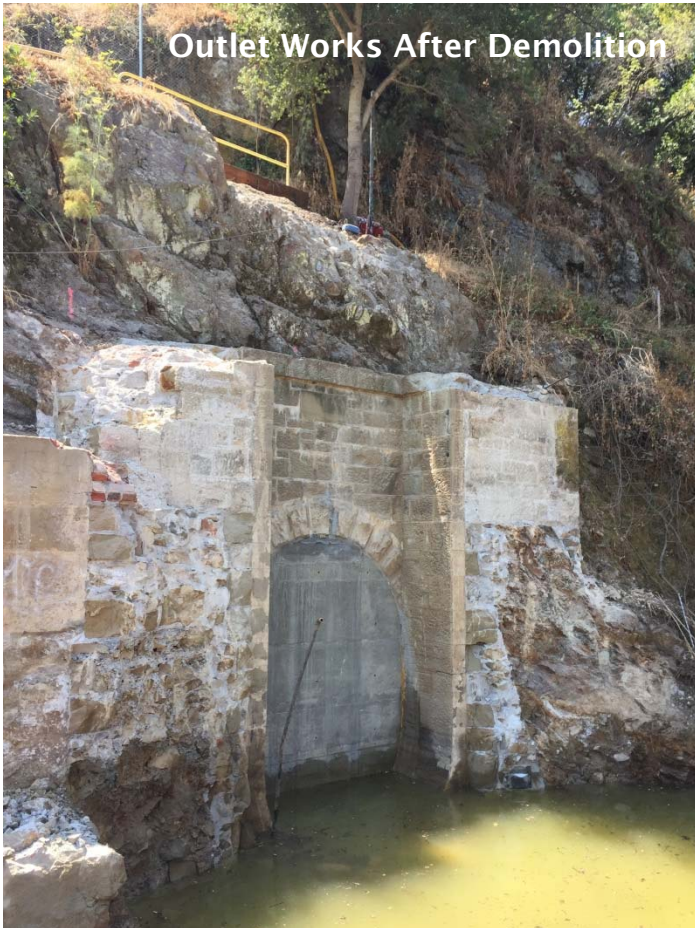
New Outlet Works  
in Rock Hillside

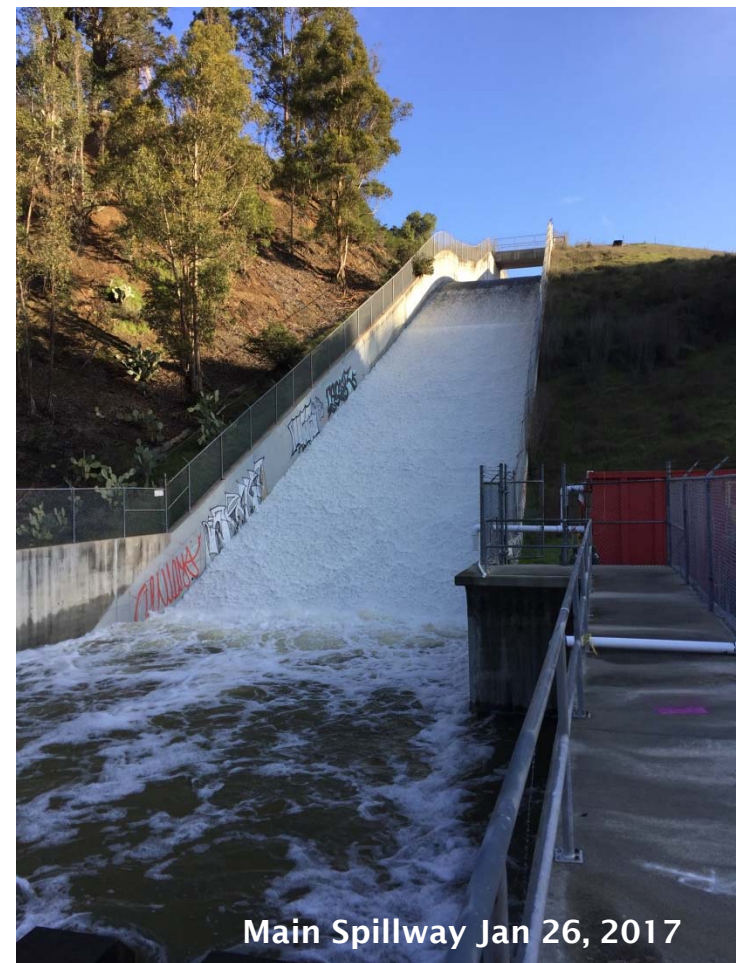
Main Spillway Jan 26, 2017

- Record breaking rainfall ~44-inches
- Spilled Jan to May 2017
- Delays to earthwork on dam
- Chabot fish go over spillway
