**Dublin San Ramon  
Services District**

# Refurbishing a Continuous Backwash Sand Filter

# Inspection and Refurbishment of a Continuous Backwash Sand Filter

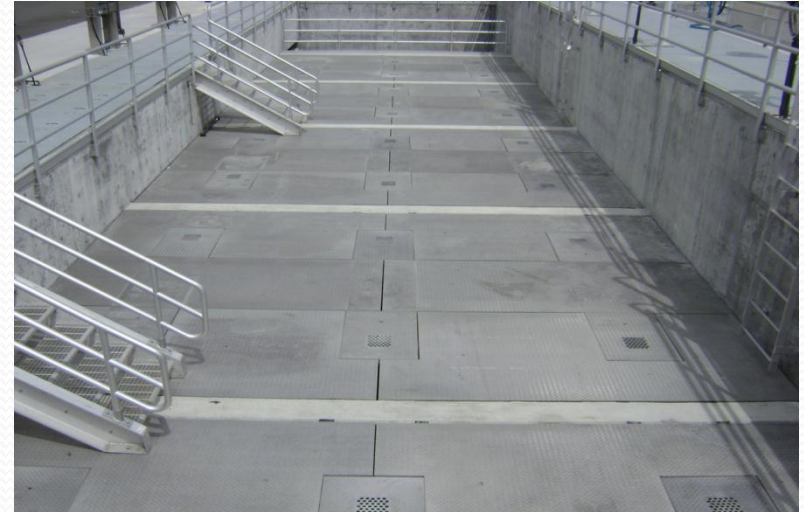
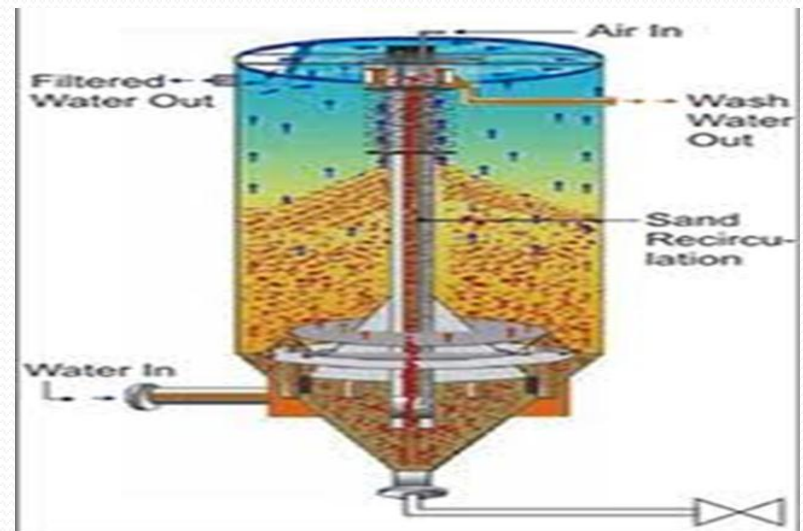
- Evaluate Existing Sand Filter Media
- Conduct a Pre-Filter Performance Test
- Remove Existing Sand
- Inspect Filter Infrastructure
- Conduct repairs as necessary
- Replace Sand Filter Media
- Conduct Post-Filter Performance Test
